The Road Inventory of Camas National Wildlife Refuge Hamer, ID

Prepared By:
Federal Highway Administration
Central Federal Lands Highway Division
April 2013

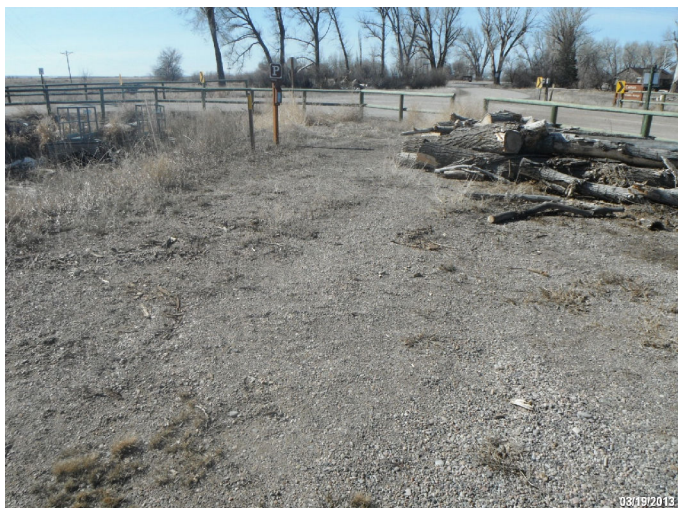
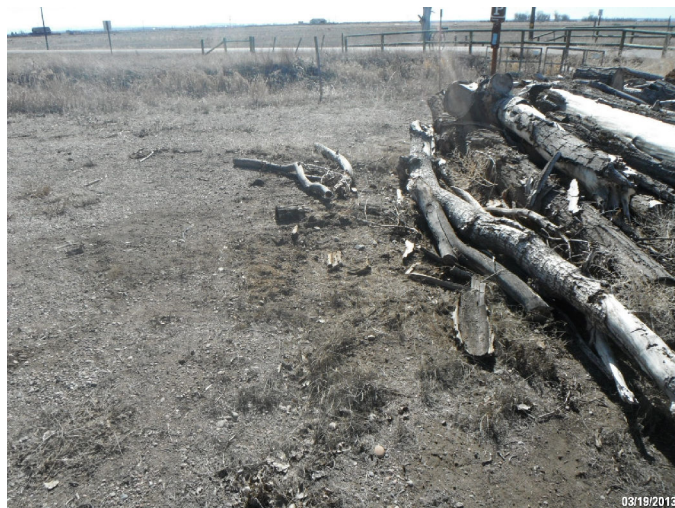
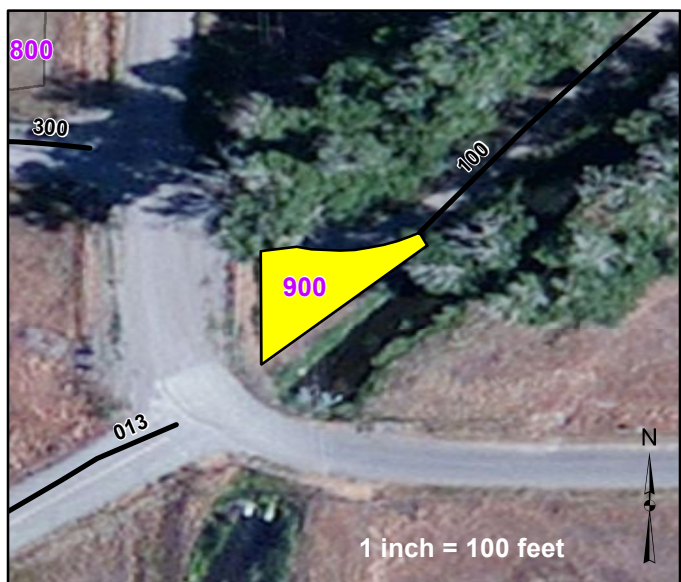
Route Number: 900
North Headquarters Hunter Access Parking
From Well #4 Loop (Route 100)

Asset Number	Area (Sq Ft)	Spaces	Condition	Surface Type	Cost to Improve	Inspection Date	Current Replacement Value
10048290	1901	4	Fair	Gravel	\$500	03-19-2013	\$8,900

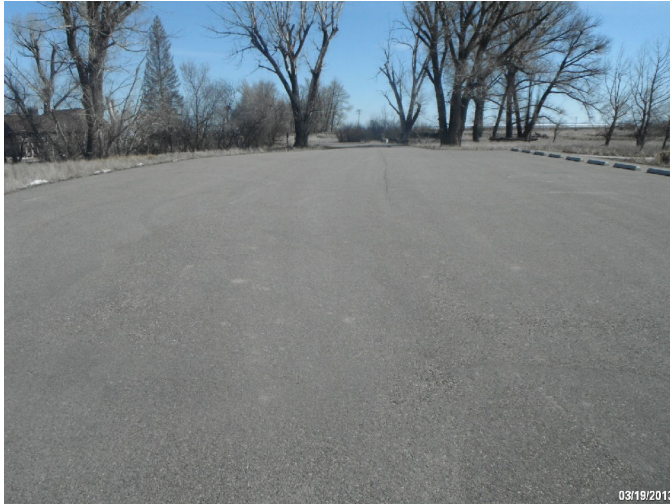
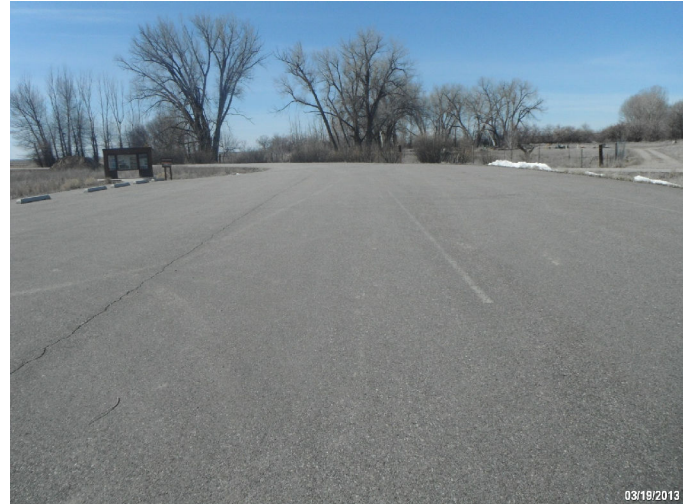
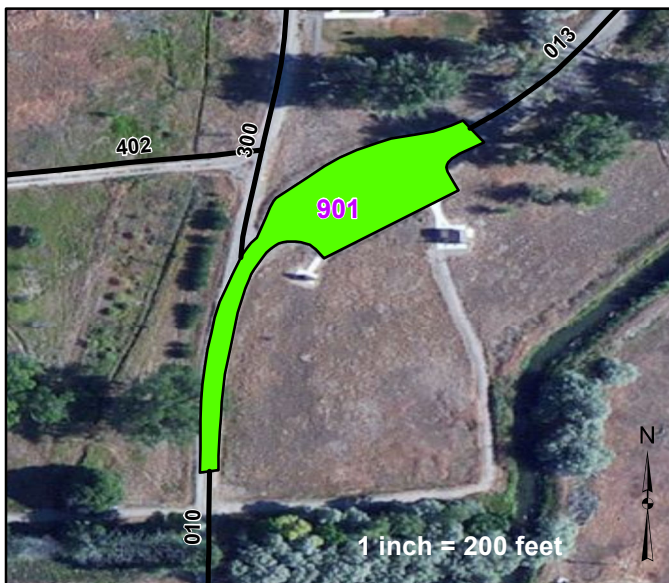
From Headquarters Entrance Road (Route 013)

Asset Number	Area (Sq Ft)	Spaces	Condition	Surface Type	Cost to Improve	Inspection Date	Current Replacement Value
-	15311	13	Good	Asphalt	\$2,700	03-19-2013	\$130,600

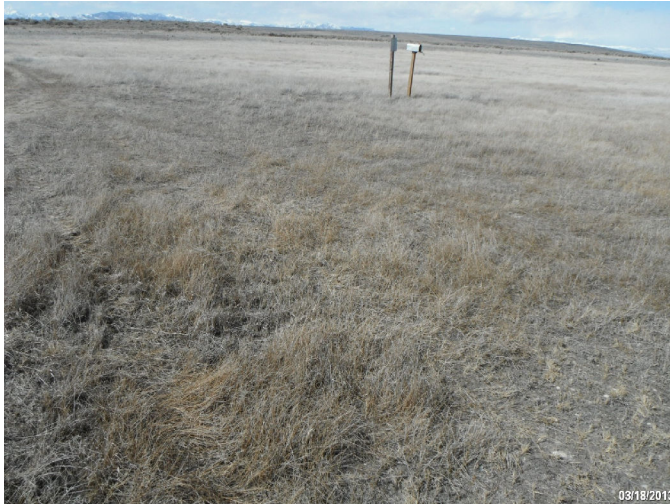
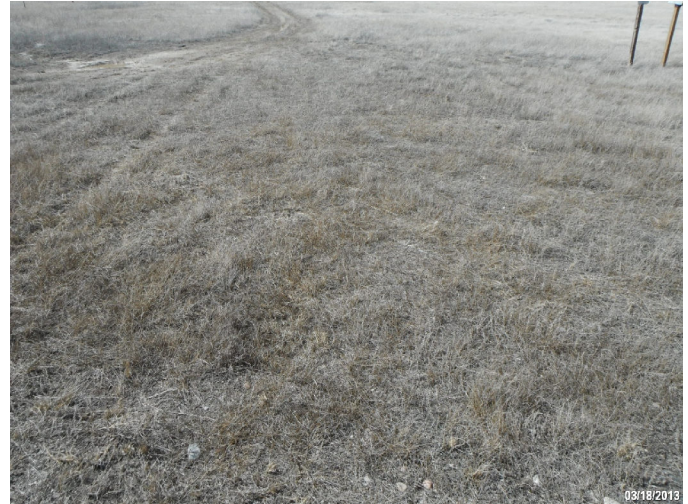
Route Number: 902
Hunter Access Parking #1
From Hunter Access Road (Route 012)

Asset Number	Area (Sq Ft)	Spaces	Condition	Surface Type	Cost to Improve	Inspection Date	Current Replacement Value
10051553	2698	5	Poor	Native	\$2,100	03-18-2013	\$5,400

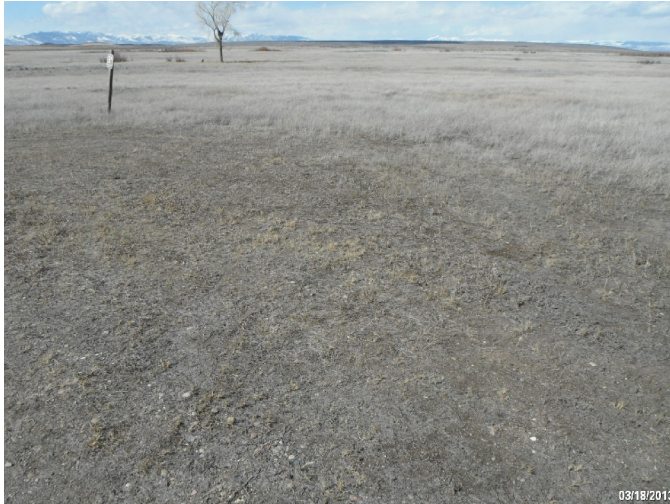
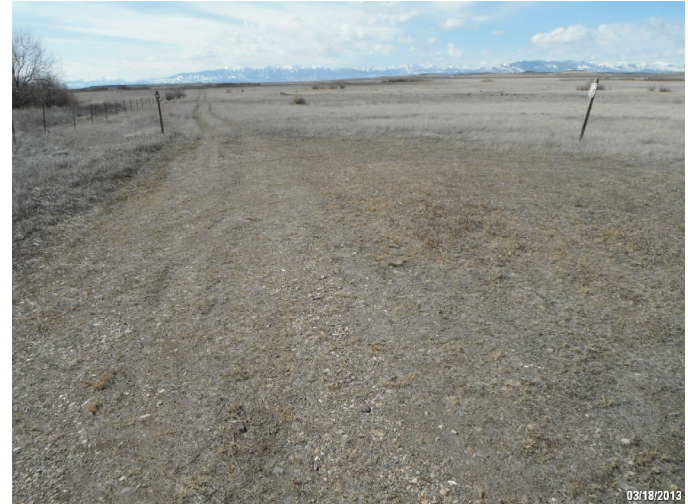
Route Number: 903
Independent Hunter Access Parking
From Independent Hunter Access Road (Route 103)

Asset Number	Area (Sq Ft)	Spaces	Condition	Surface Type	Cost to Improve	Inspection Date	Current Replacement Value
10051554	5443	5	Fair	Gravel	\$1,400	03-18-2013	\$25,300

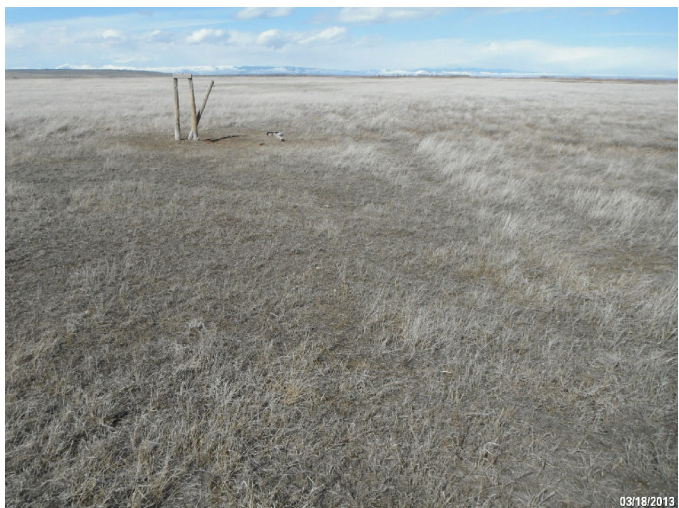
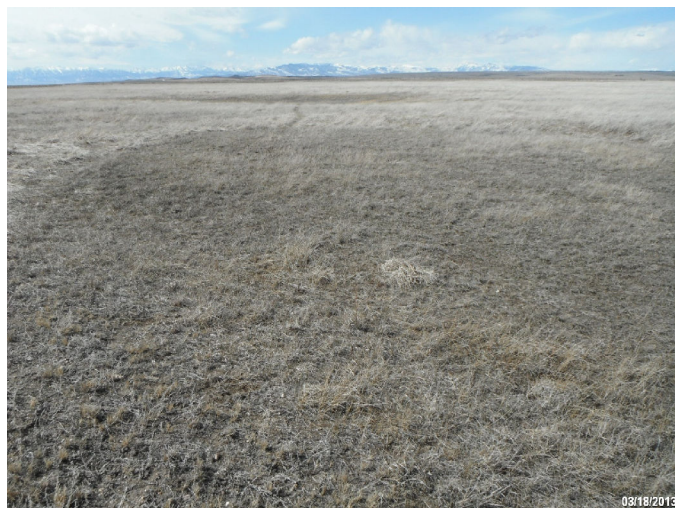
Route Number: 904
Hunter Access Parking #2
From Hunter Access Road (Route 012)

Asset Number	Area (Sq Ft)	Spaces	Condition	Surface Type	Cost to Improve	Inspection Date	Current Replacement Value
10051555	5494	12	Fair	Native	\$1,400	03-18-2013	\$11,000

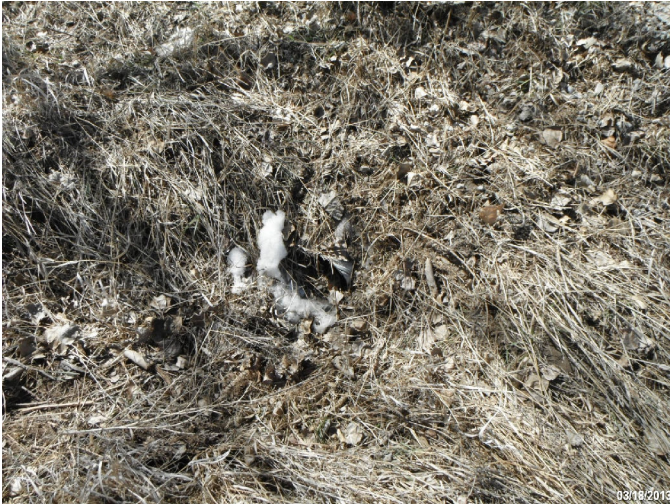
Photo: CAMA_C4_0478 Route: 010-001-0.01
Metal Culvert 20ft long 12in dia. 2ft deep

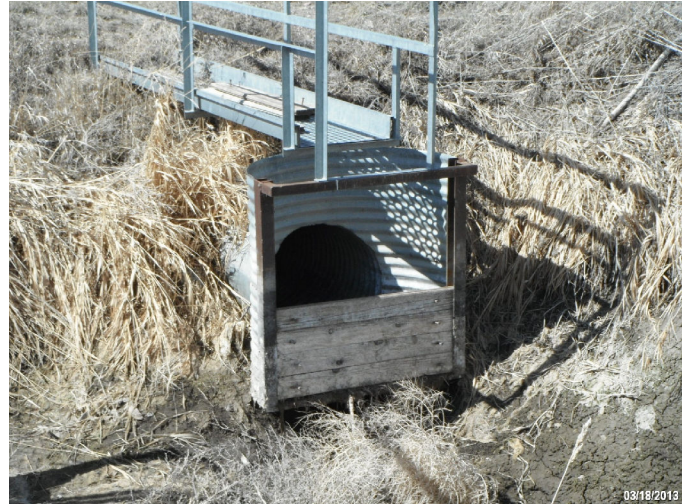
Photo: CAMA_C4_0479 Route: 010-001-0.07
Metal WCS Flashboard Riser 60ft long 36in dia. 3ft deep

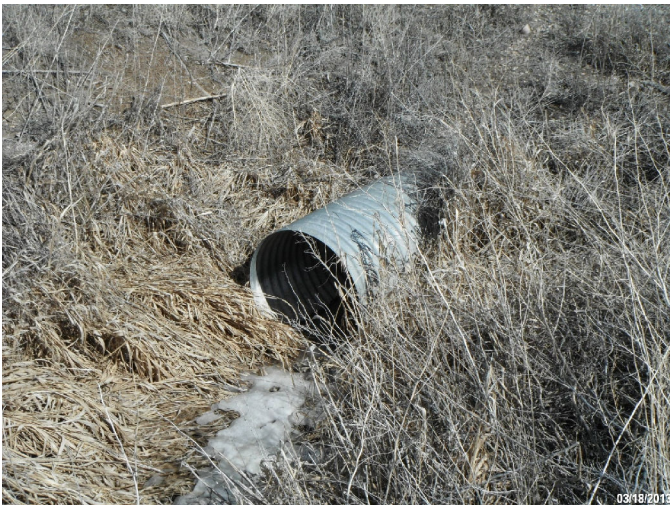
Photo: CAMA_C4_0480 Route: 010-001-0.07
Metal WCS Flashboard Riser 60ft long 36in dia. 3ft deep

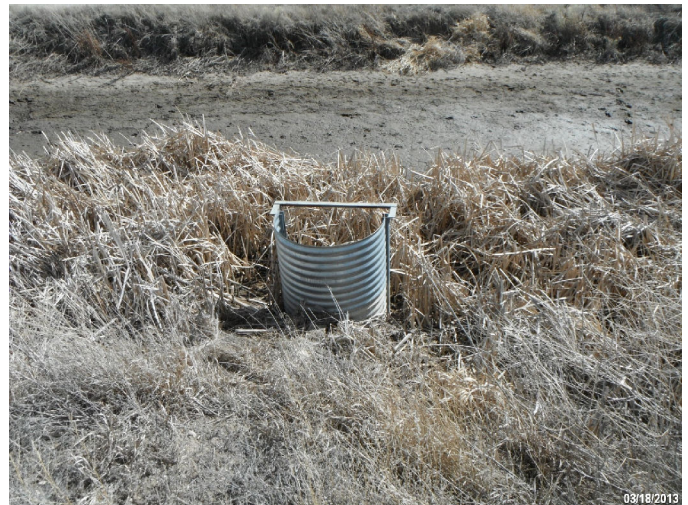
Photo: CAMA_C4_0481 Route: 010-001-0.58
Metal WCS Flashboard Riser 40ft long 24in dia. 2ft deep
8-001

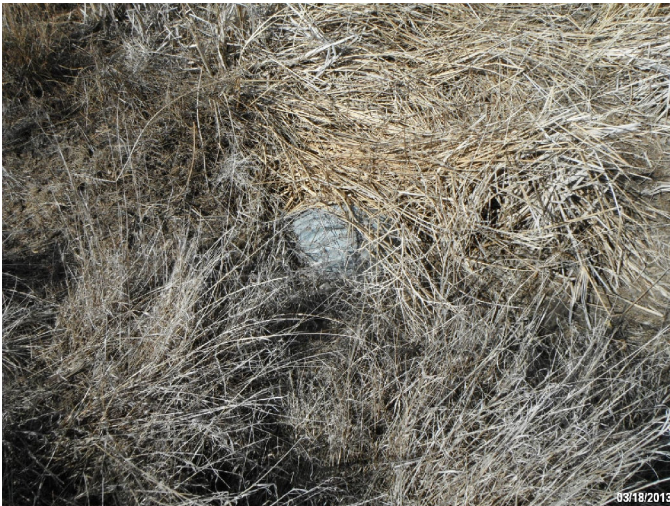
Photo: CAMA_C4_0482 Route: 010-001-0.58
Metal WCS Flashboard Riser 40ft long 24in dia. 2ft deep

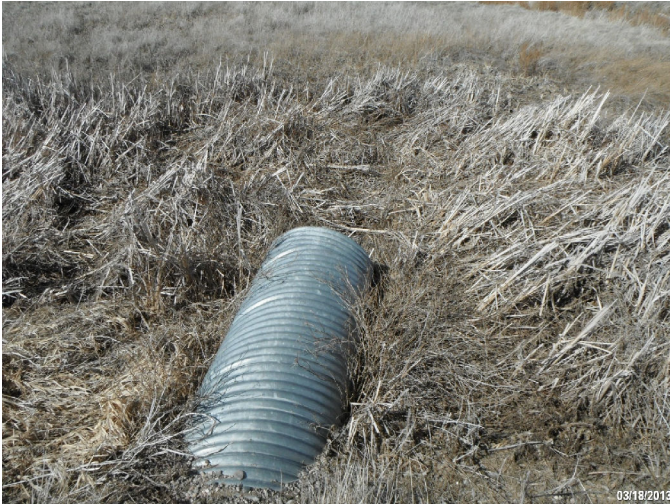
Photo: CAMA_C4_0484 Route: 010-001-0.73
Metal WCS Flashboard Riser 50ft long 36in dia. 3ft deep

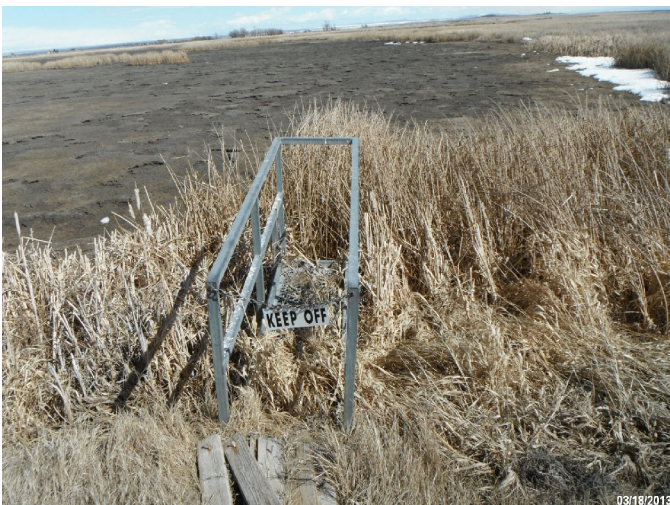
Photo: CAMA_C4_0486 Route: 010-002-1.26
Metal WCS Flashboard Riser 40ft long 24in dia. 3ft deep

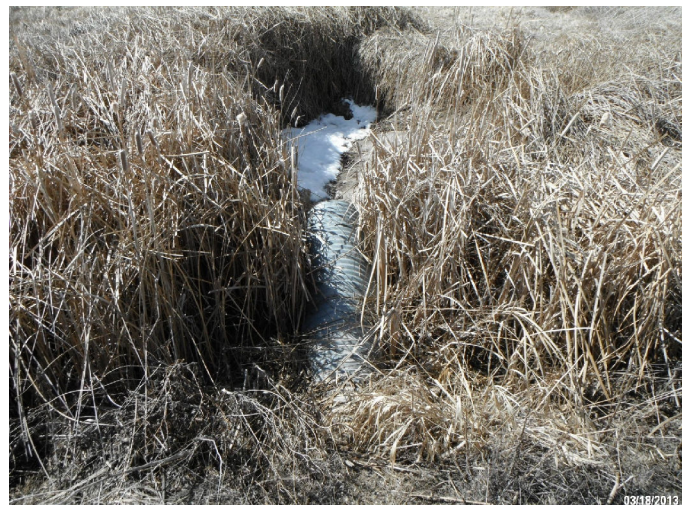
Photo: CAMA_C4_0487 Route: 010-002-1.26
Metal WCS Flashboard Riser 40ft long 24in dia. 3ft deep
8-002

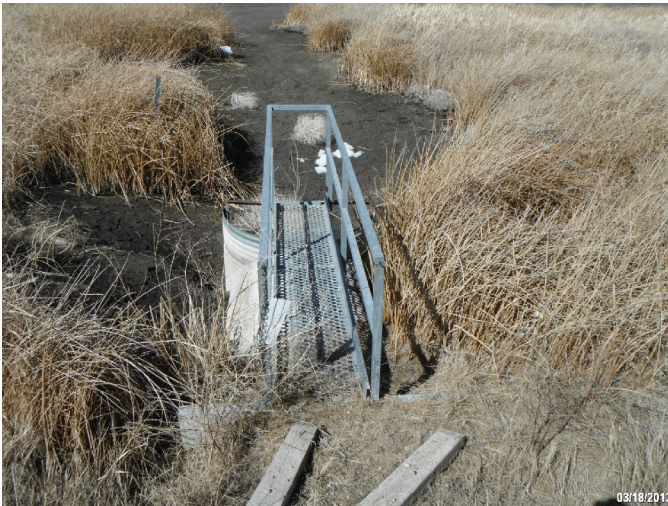
Photo: CAMA_C4_0488 Route: 010-002-1.7
Metal WCS Flashboard Riser 50ft long 48in dia. 3ft deep

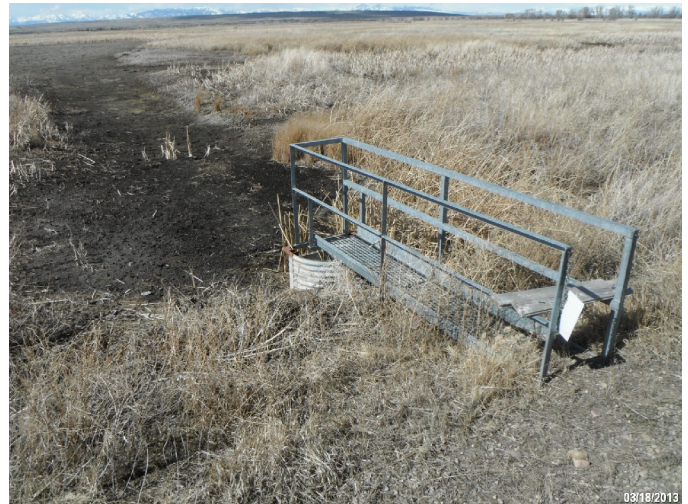
Photo: CAMA_C4_0491 Route: 010-003-2.13
Metal WCS Flashboard Riser 50ft long 24in dia. 3ft deep

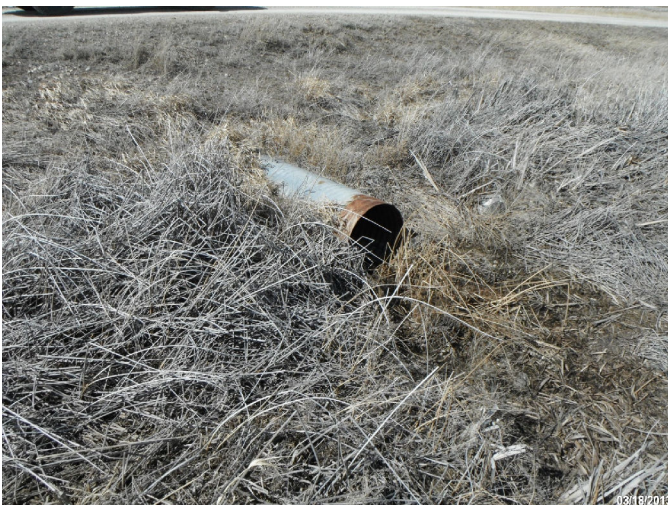
Photo: CAMA_C4_0492 Route: 010-003-2.13
Metal WCS Flashboard Riser 50ft long 24in dia. 3ft deep

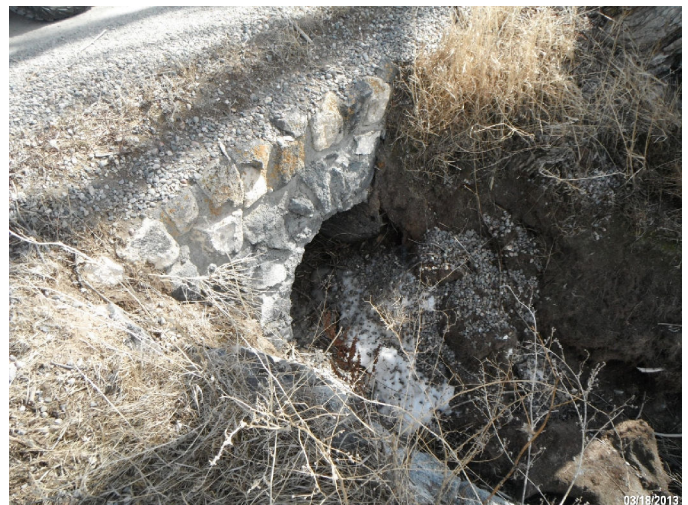
Photo: CAMA_C4_0493 Route: 010-003-2.42
Concrete Culvert 20ft long 36in dia. 3ft deep

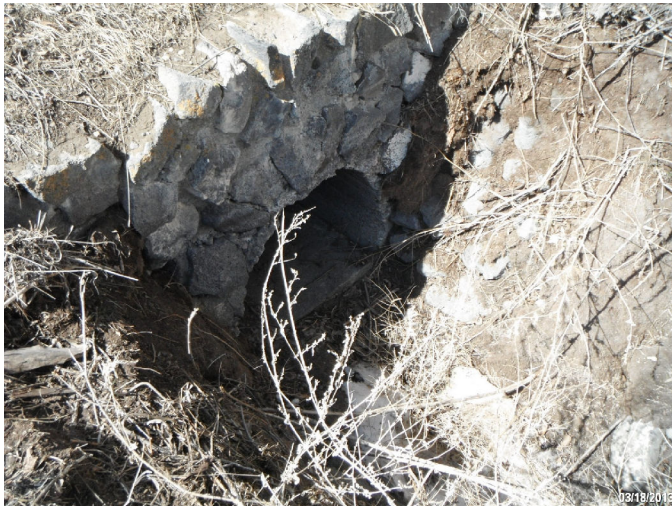
Photo: CAMA_C4_0494 Route: 010-003-2.42
Concrete Culvert 20ft long 36in dia. 3ft deep

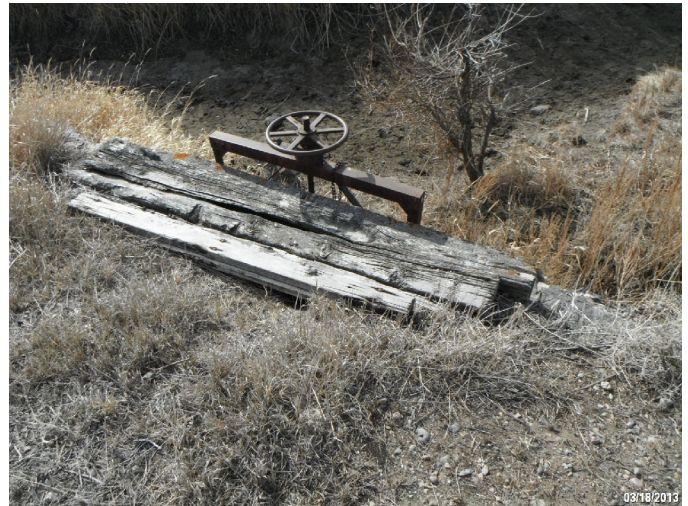
Photo: CAMA_C4_0542 Route: 011-001-0.64
Concrete WCS Screw Gate 40ft long 48in dia. 6ft deep

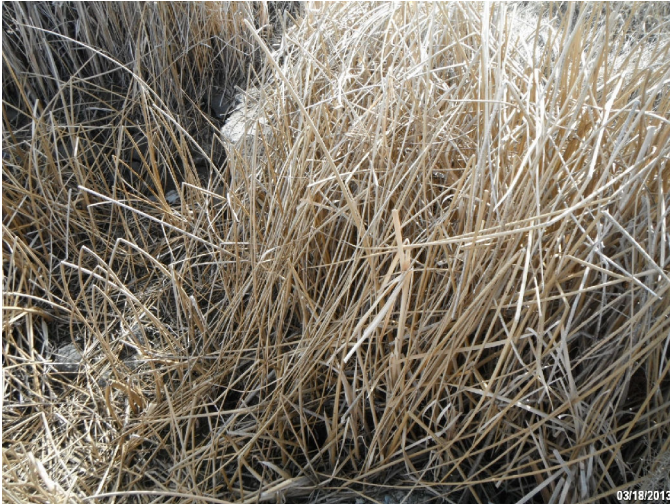
Photo: CAMA_C4_0543 Route: 011-001-0.64
Concrete WCS Screw Gate 40ft long 48in dia. 6ft deep

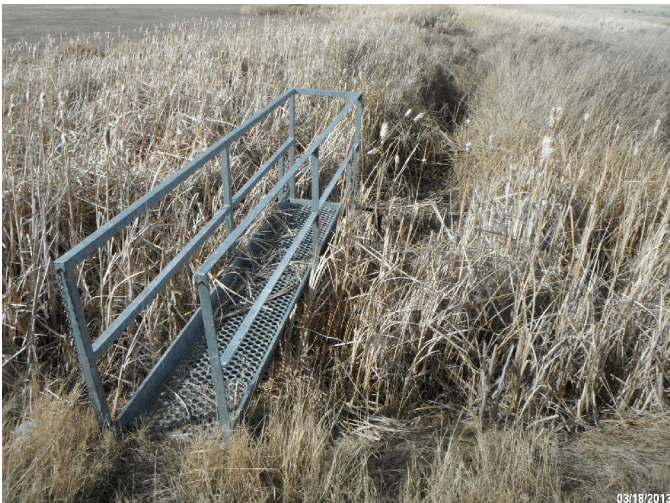
Photo: CAMA_C4_0545 Route: 011-002-1.56
Metal WCS Flashboard Riser 50ft long 36in dia. 3ft deep

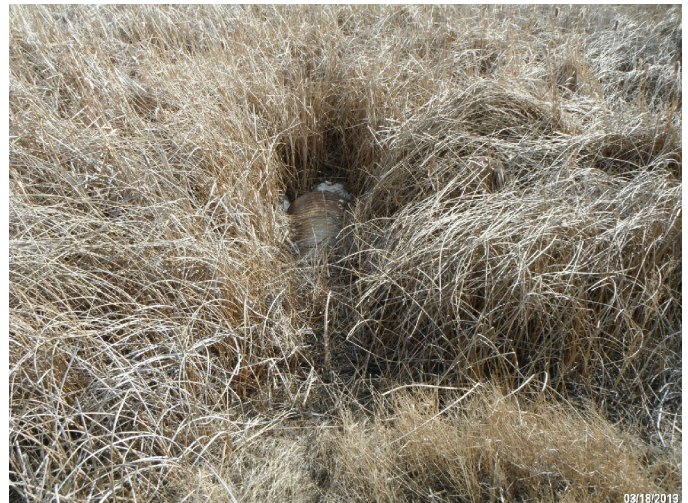
Photo: CAMA_C4_0546 Route: 011-002-1.56
Metal WCS Flashboard Riser 50ft long 36in dia. 3ft deep
8-005

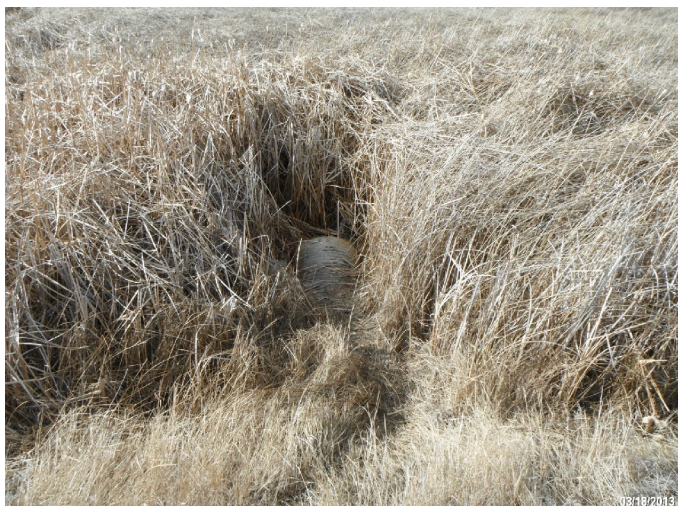
Photo: CAMA_C4_0547 Route: 011-002-1.74
Metal WCS Flashboard Riser 50ft long 36in dia. 3ft deep

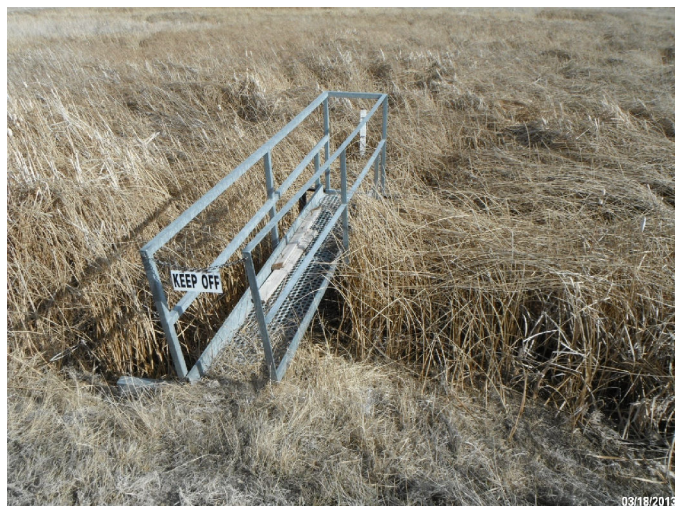
Photo: CAMA_C4_0548 Route: 011-002-1.74
Metal WCS Flashboard Riser 50ft long 36in dia. 3ft deep

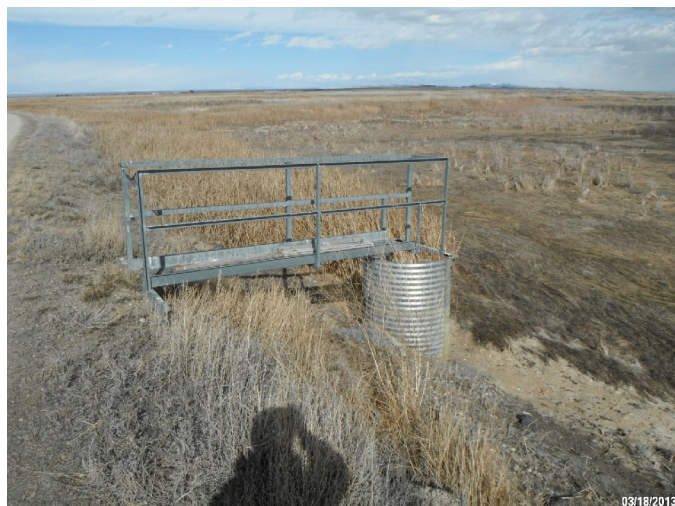
Photo: CAMA_C4_0550 Route: 011-003-1.96
Metal WCS Flashboard Riser 40ft long 36in dia. 3ft deep

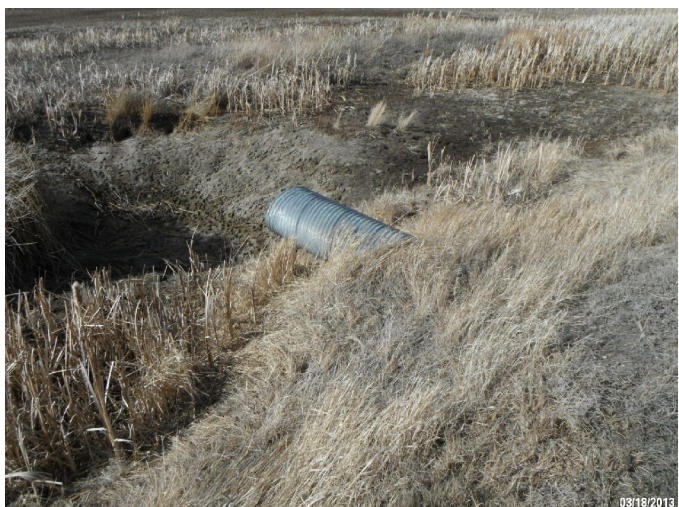
Photo: CAMA_C4_0551 Route: 011-003-1.96
Metal WCS Flashboard Riser 40ft long 36in dia. 3ft deep

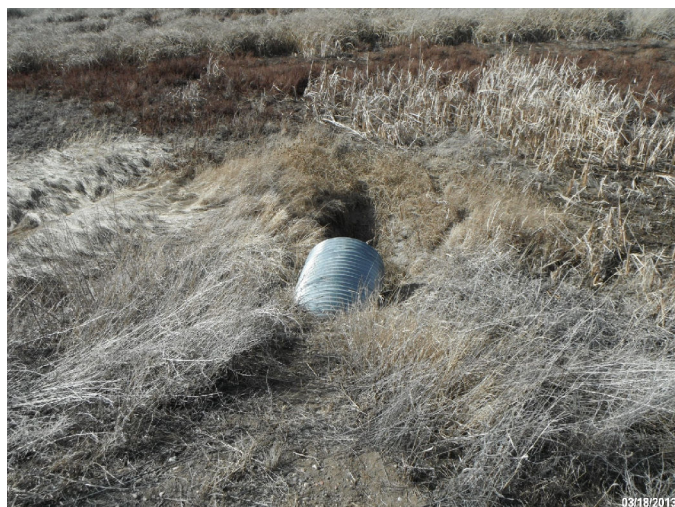
Photo: CAMA_C4_0552 Route: 011-003-2.48
Metal WCS Flashboard Riser 40ft long 36in dia. 3ft deep
8-006

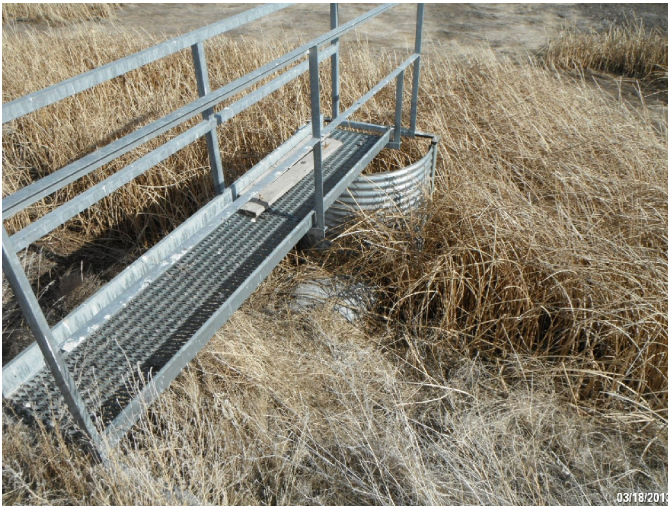
Photo: CAMA_C4_0553 Route: 011-003-2.48
Metal WCS Flashboard Riser 40ft long 36in dia. 3ft deep

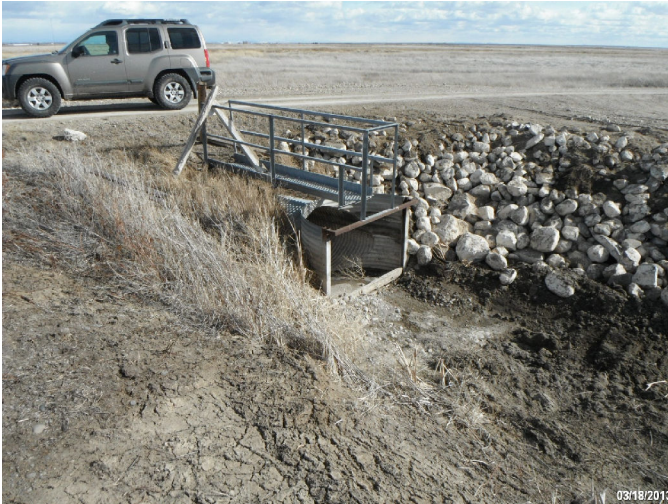
Photo: CAMA_C4_0555 Route: 011-004-3.02
Metal WCS Flashboard Riser 50ft long 48in dia. 3ft deep

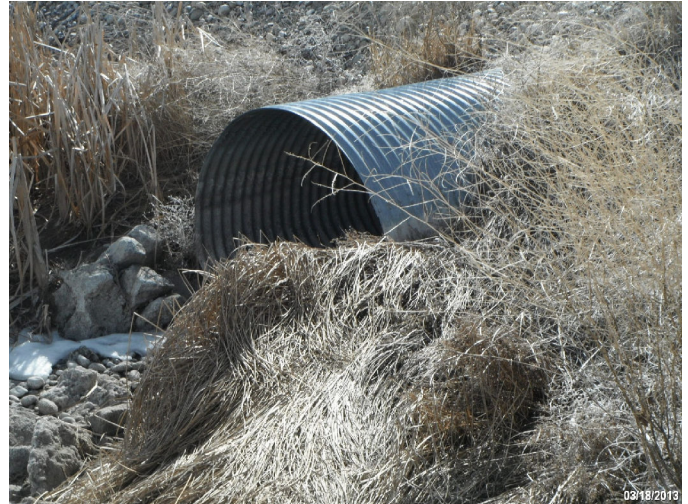
Photo: CAMA_C4_0556 Route: 011-004-3.02
Metal WCS Flashboard Riser 50ft long 48in dia. 3ft deep

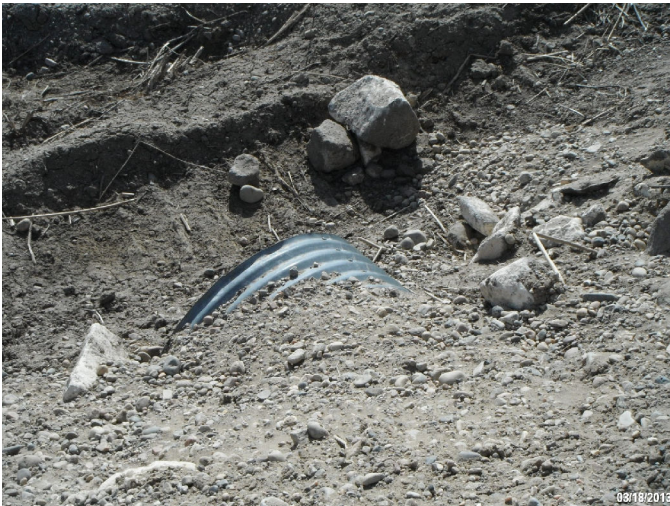
Photo: CAMA_C4_0559 Route: 011-005-3.06

Metal WCS Flashboard Riser 40ft long 36in dia. 3ft deep

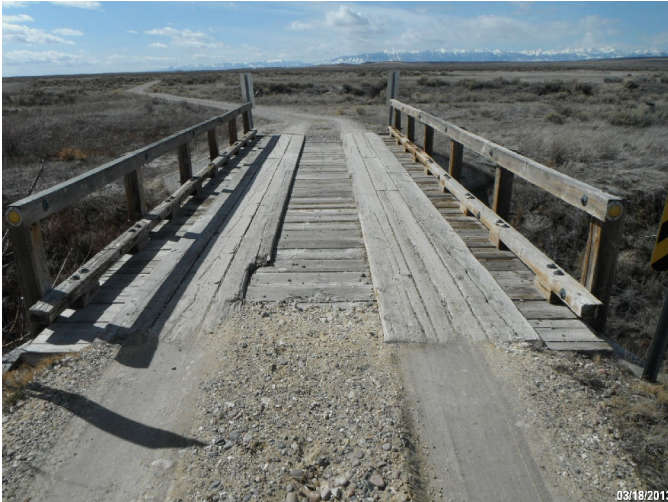
Photo: CAMA_C4_0500 Route: 012-001-0.65
Wood Bridge NBIS:14611-000291
See CAMA_C4_0501, CAMA_C4_0502

Camas Bridge Inventory					
Rte #	Milepost	NBIS #	Sufficiency Rating	Functionally Obsolete	Structurally Deficient
12	0.65	14611-000291	599	N	Y
400	1.11	NA	NA	NA	NA
401	0	14611-000951	729	N	Y
403	0.02	14611-000311	739	N	N
406	0.35	14611-000271	729	N	Y
407	0.34	14611-000281	413	N	N
413	0.72	NA	NA	NA	NA

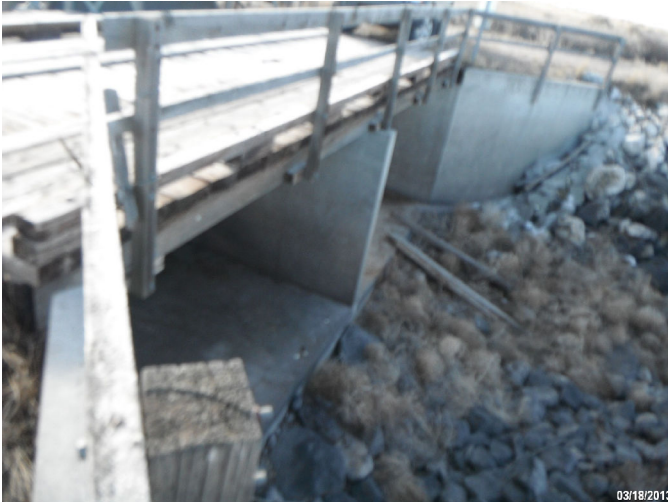
Photo: CAMA_C4_0427 Route: 401-001-0.0
Concrete WCS Other 20ft long Nonein dia. 1ft deep
15x30 rotary gate

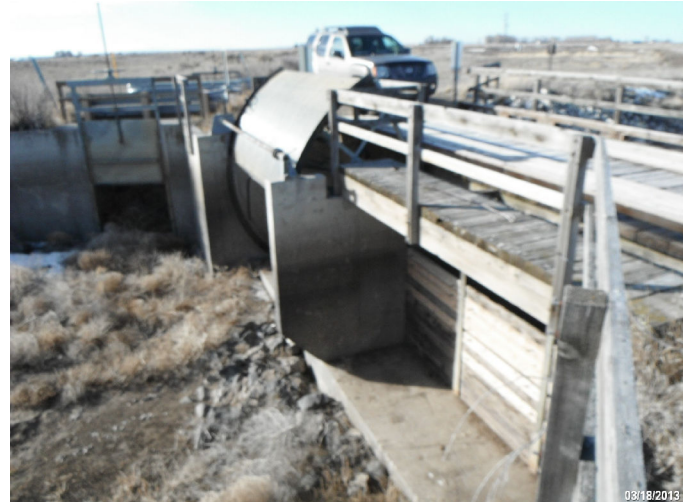
Photo: CAMA_C4_0428 Route: 401-001-0.0
Concrete WCS Other 20ft long Nonein dia. 1ft deep
15x30 rotary gate

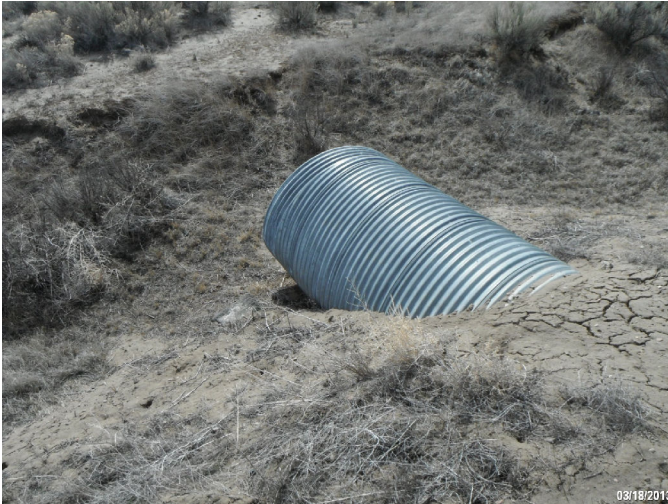
Photo: CAMA_C4_0453 Route: 404-001-0.61
Metal WCS Flashboard Riser 50ft long 48in dia. 1ft deep
Elliptical

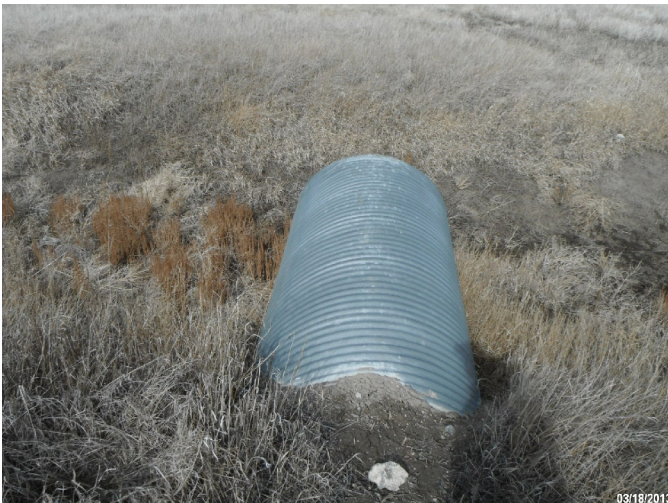
Photo: CAMA_C4_0455 Route: 404-002-0.97
Metal WCS Flashboard Riser 30ft long 48in dia. 1ft deep

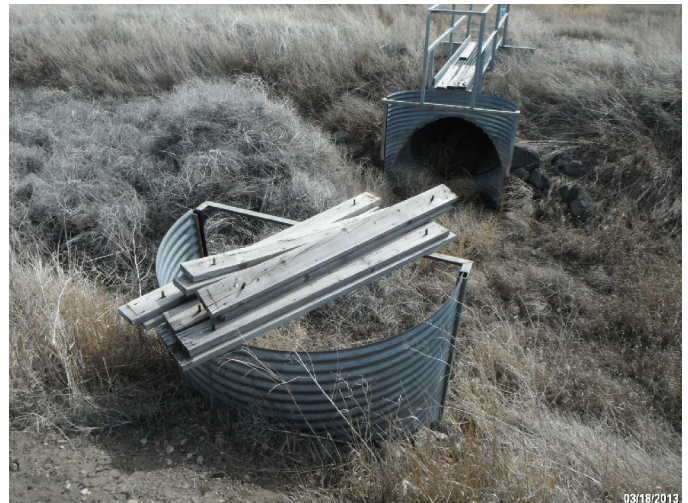
Photo: CAMA_C4_0456 Route: 404-002-0.97
Metal WCS Flashboard Riser 30ft long 48in dia. 1ft deep
8-021

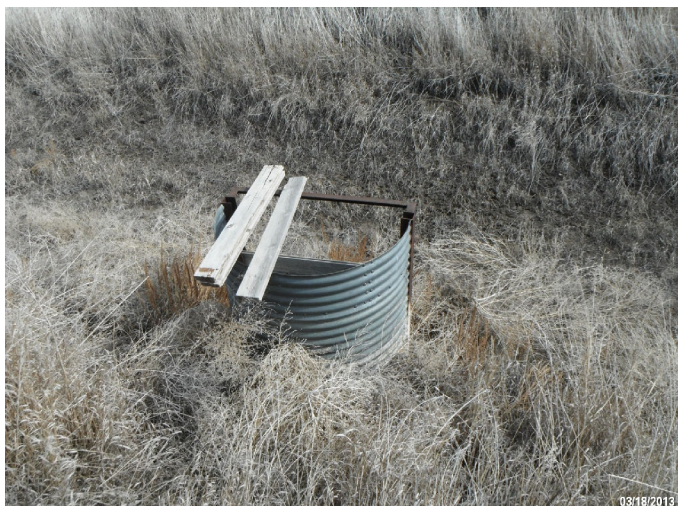
Photo: CAMA_C4_0457 Route: 404-002-1.32
Metal WCS Flashboard Riser 50ft long 30in dia. 4ft deep

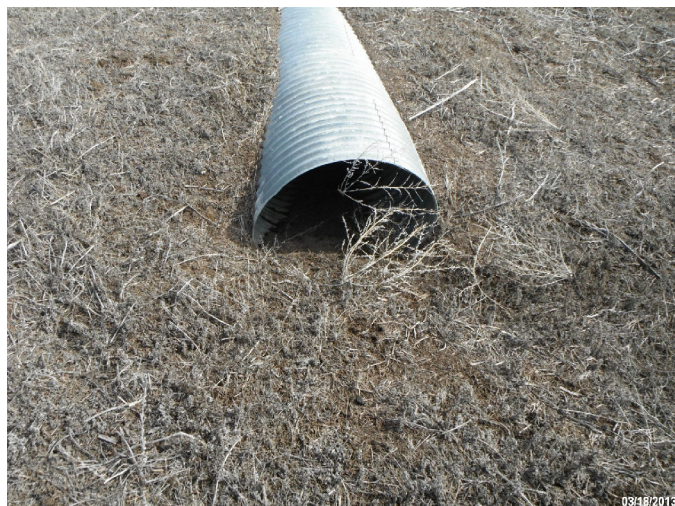
Photo: CAMA_C4_0458 Route: 404-002-1.32
Metal WCS Flashboard Riser 50ft long 30in dia. 4ft deep

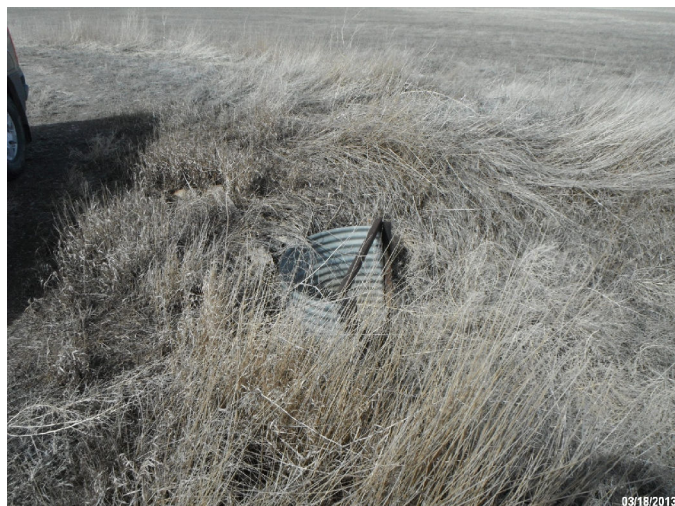
Photo: CAMA_C4_0460 Route: 404-003-1.74
Metal WCS Flashboard Riser 25ft long 36in dia. 3ft deep

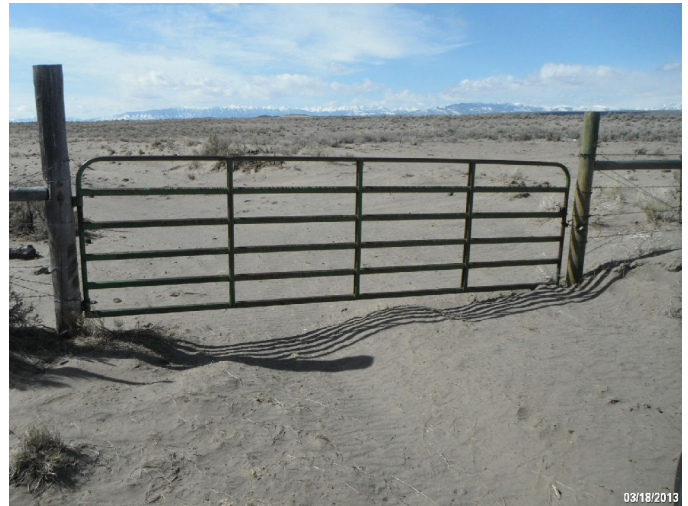
Photo: CAMA_C4_0507 Route: 405-001-0.29
Metal Open Rail Gate

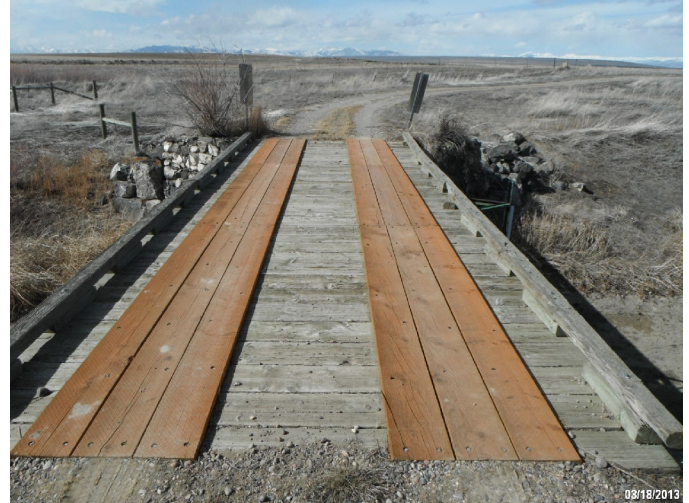
Photo: CAMA_C4_0527 Route: 406-001-0.35
Wood Bridge NBIS:14611-000271
See CAMA_C4_0528, CAMA_C4_0529

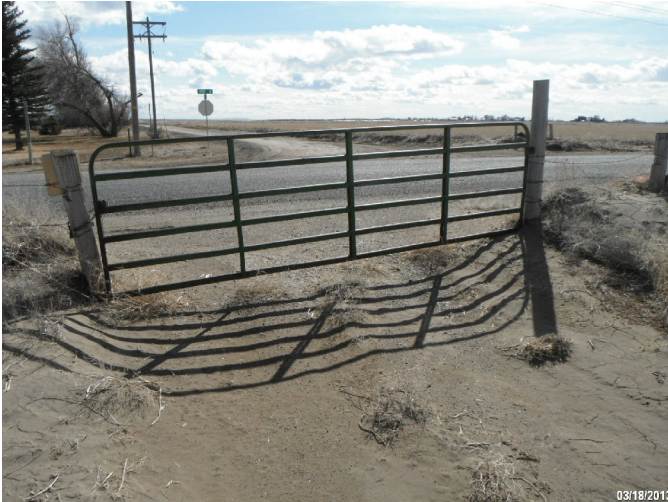
Photo: CAMA_C4_0530 Route: 406-001-0.84
Metal Open Rail Gate

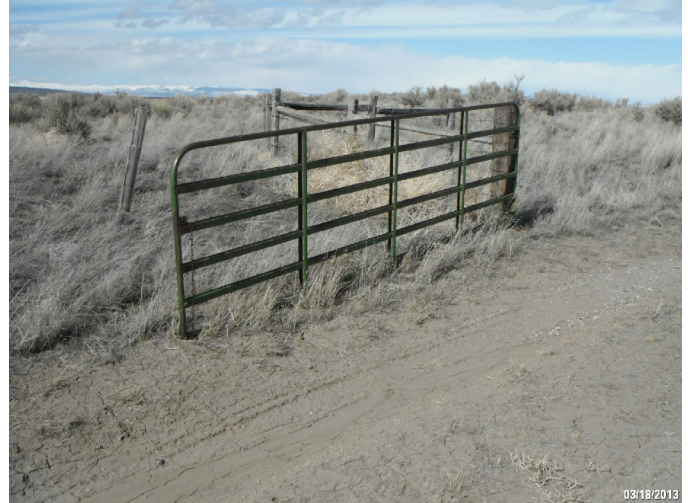
Photo: CAMA_C4_0532 Route: 407-001-0.01
Metal Open Rail Gate

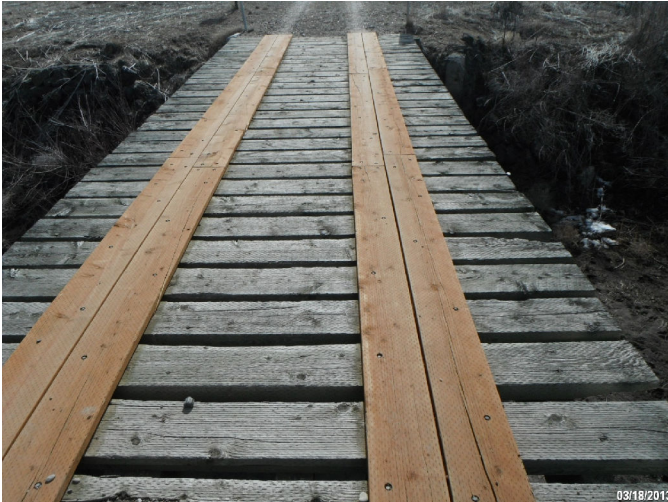
Photo: CAMA_C4_0533 Route: 407-001-0.34
Wood Bridge NBIS:14611-000281
See CAMA_C4_0534, CAMA_C4_0535

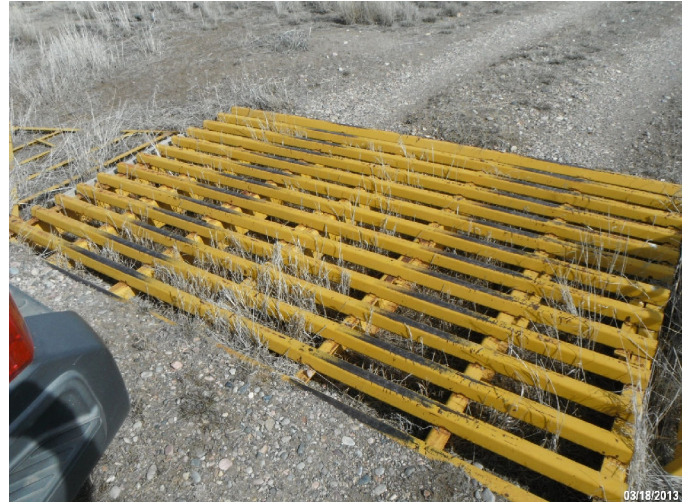
Photo: CAMA_C4_0536 Route: 407-001-0.41
Metal Cattle Guard

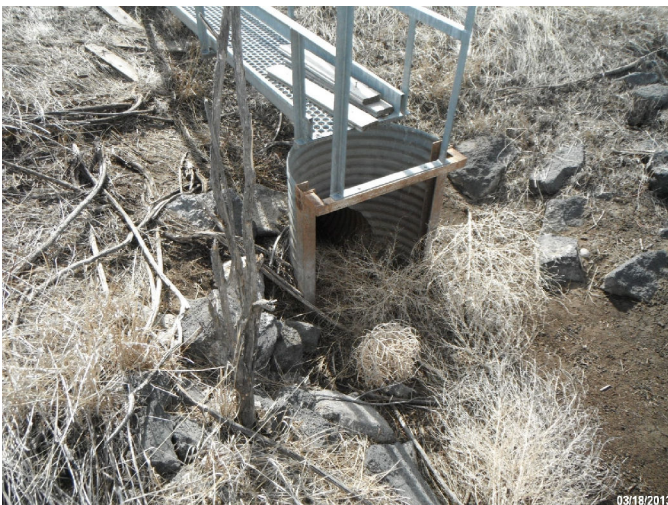
Photo: CAMA_C4_0537 Route: 407-001-0.42
Metal WCS Flashboard Riser 50ft long 24in dia. 3ft deep

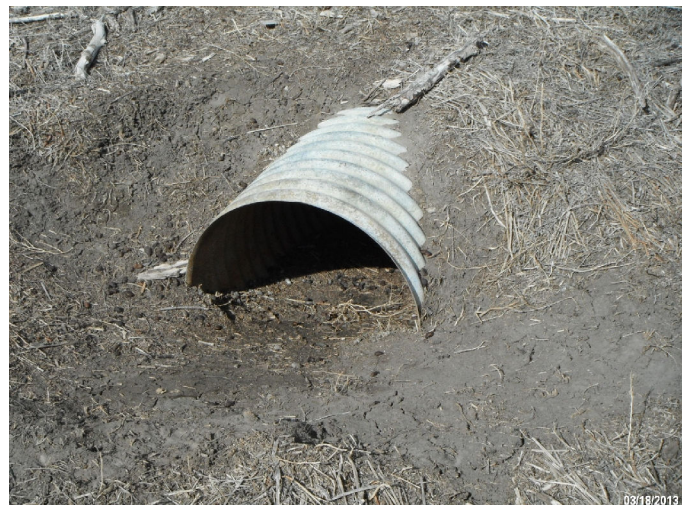
Photo: CAMA_C4_0538 Route: 407-001-0.42
Metal WCS Flashboard Riser 50ft long 24in dia. 3ft deep
8-025

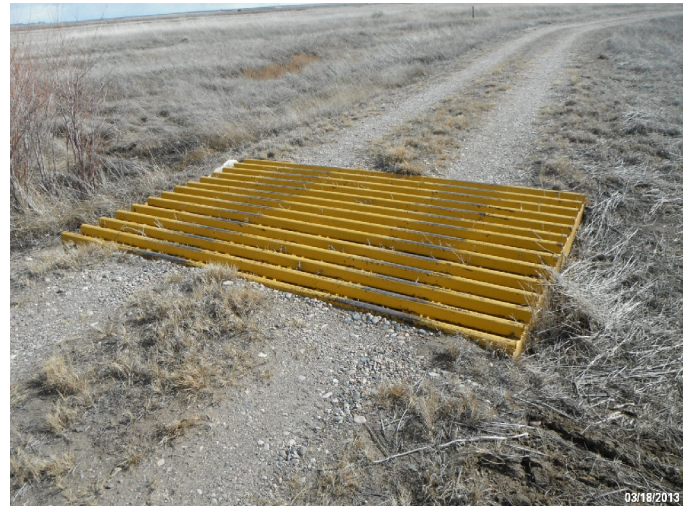
Photo: CAMA_C4_0540 Route: 407-002-1.43
Metal Cattle Guard

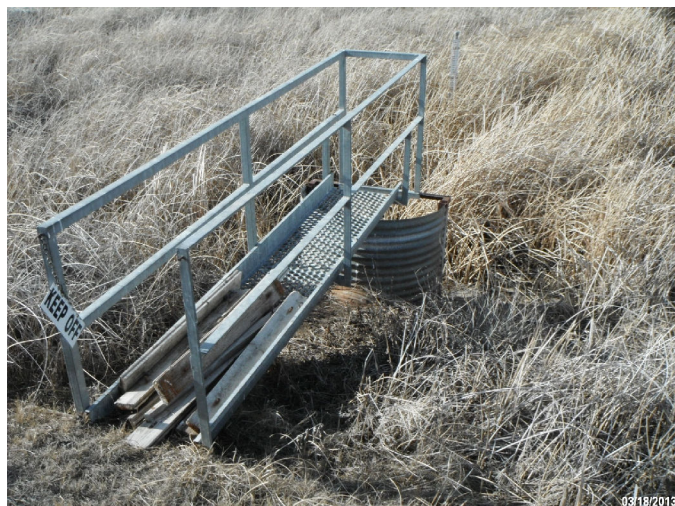
Photo: CAMA_C4_0561 Route: 408-001-0.17
Metal WCS Flashboard Riser 50ft long 36in dia. 3ft deep

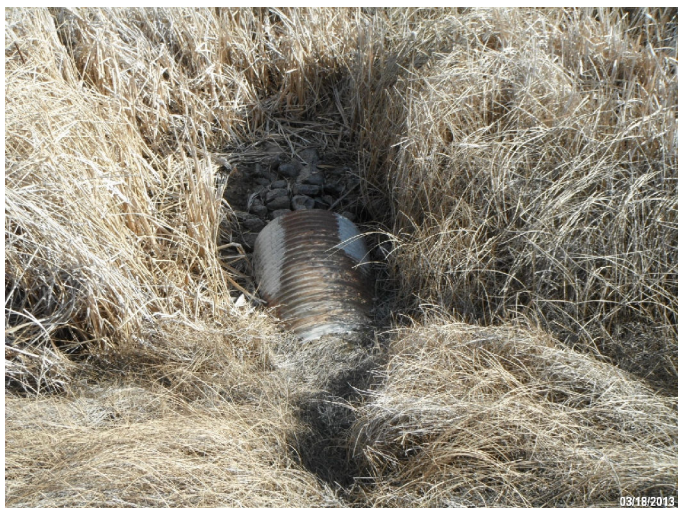
Photo: CAMA_C4_0562 Route: 408-001-0.17
Metal WCS Flashboard Riser 50ft long 36in dia. 3ft deep

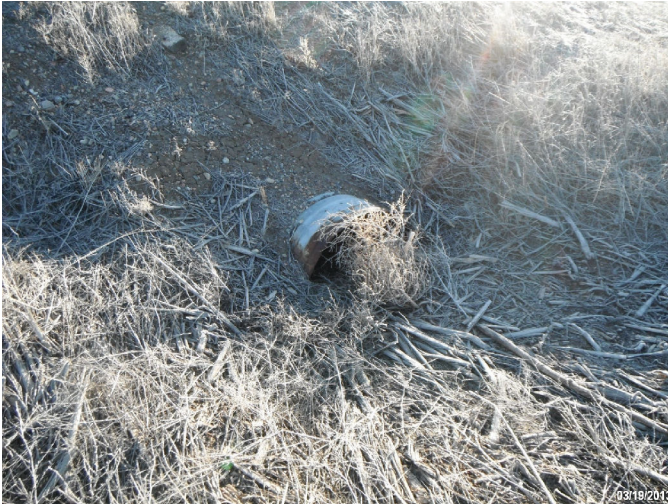
Photo: CAMA_C4_0567 Route: 409-001-0.41
Metal WCS Flashboard Riser 30ft long 36in dia. 3ft deep

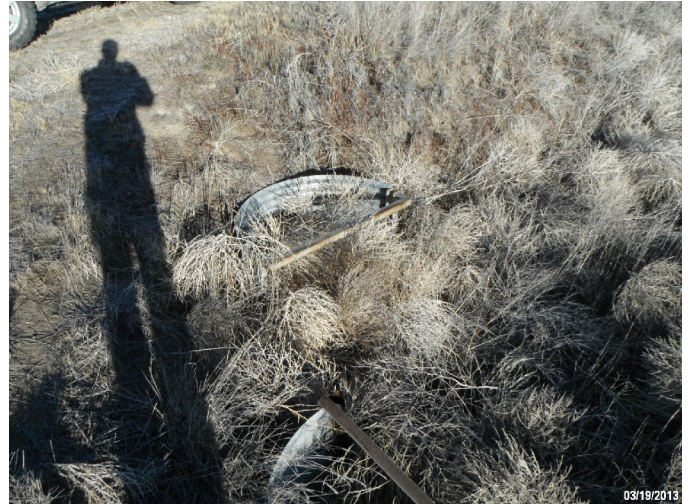
Photo: CAMA_C4_0568 Route: 409-001-0.79
Metal WCS Flashboard Riser 40ft long 36in dia. 2ft deep

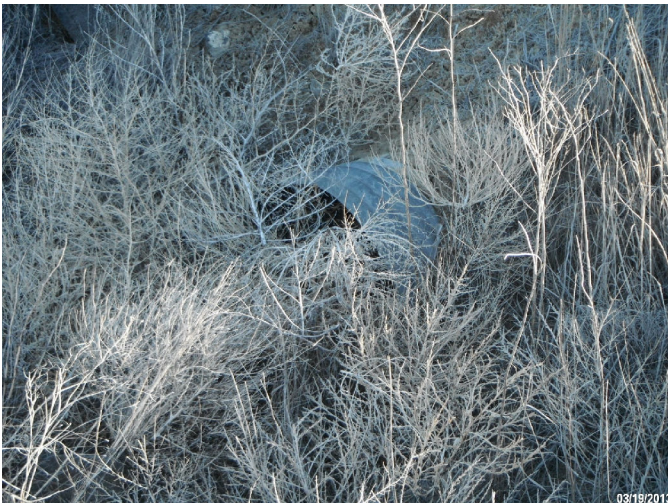
Photo: CAMA_C4_0569 Route: 409-001-0.79
Metal WCS Flashboard Riser 40ft long 36in dia. 2ft deep

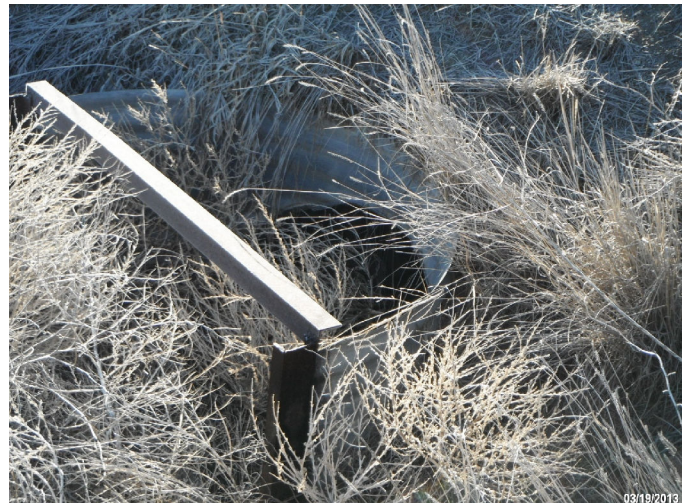
Photo: CAMA_C4_0570 Route: 409-001-0.79
Metal WCS Flashboard Riser 20ft long 36in dia. 2ft deep
8-028
